INSPECTION IMAGES

HOUSE SLOPES OVERVIEWS

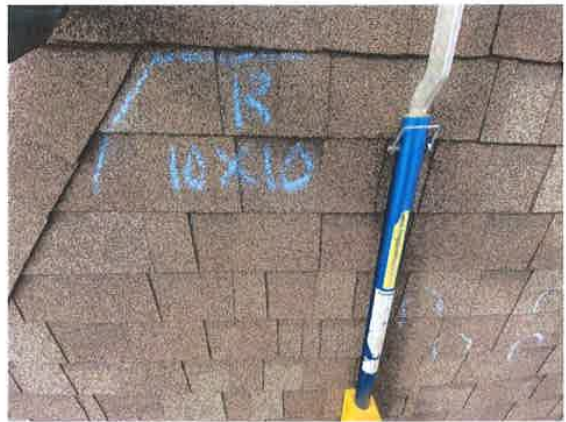
Right Slope - Damage Assessment

Hail - 0

Wind - 0

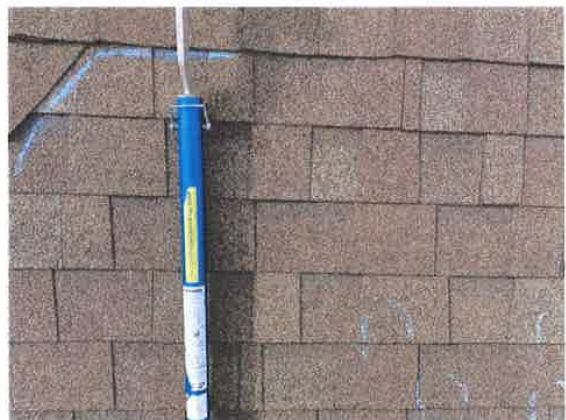
Right Slope - Roof Condition

Good Condition

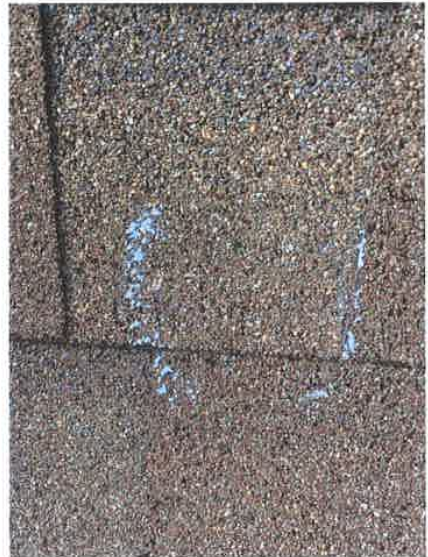
Right Slope - Roof Condition

Good Condition

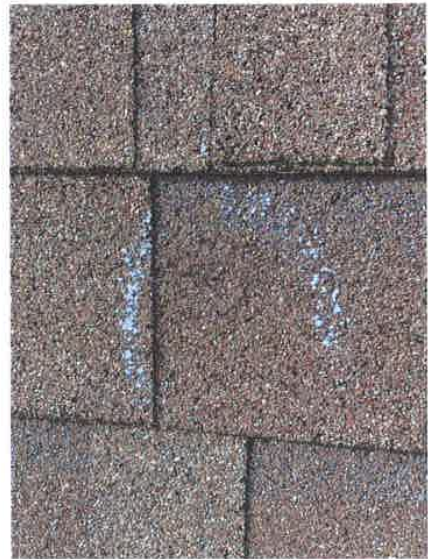
Right Slope - Roof Condition

Good Condition

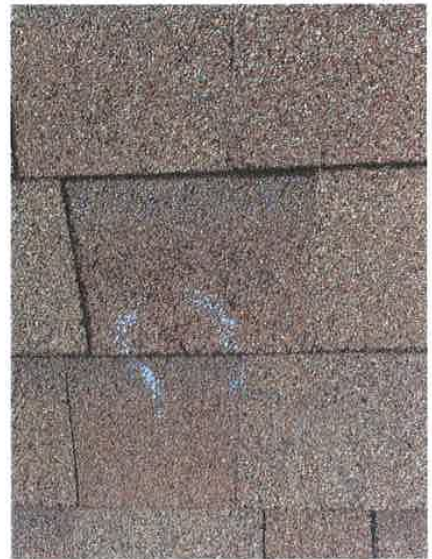
Right Slope - Roof Condition

Good Condition

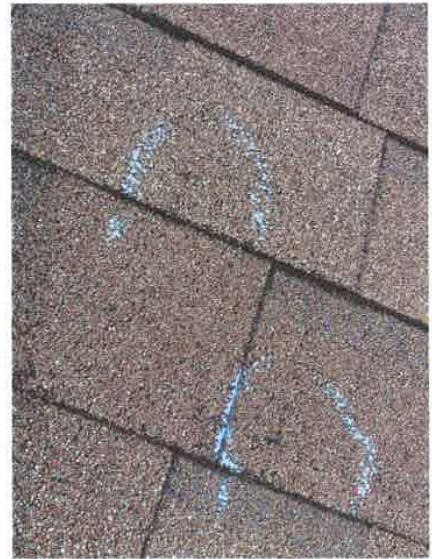
Right Slope - Roof Condition

Good Condition

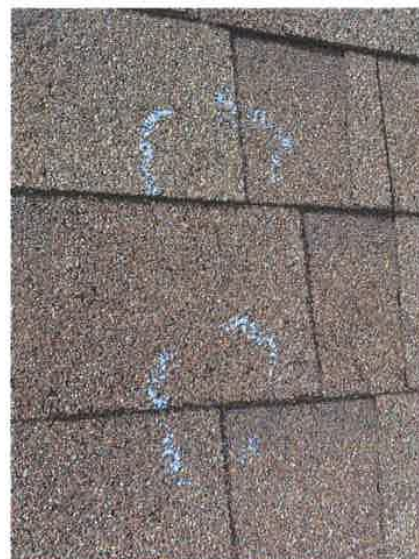
Right Slope - Roof Condition

Good Condition

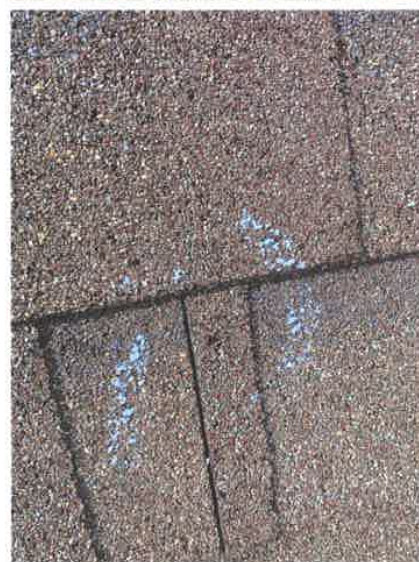
Right Slope - Roof Condition

Good Condition

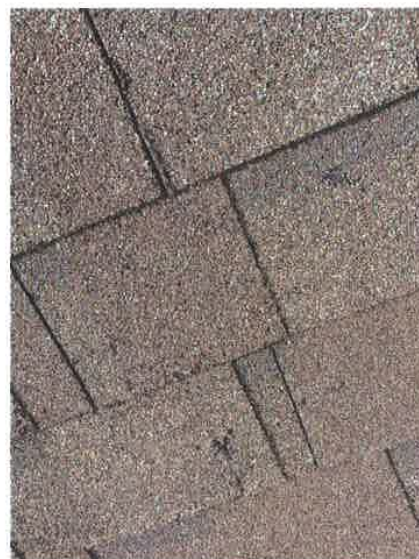
Right Slope - Roof Condition

Fair Condition

Deterioration

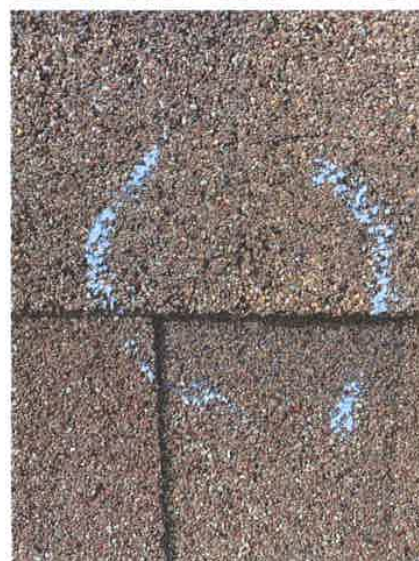
Right Slope - Roof Condition

Fair Condition

Deterioration

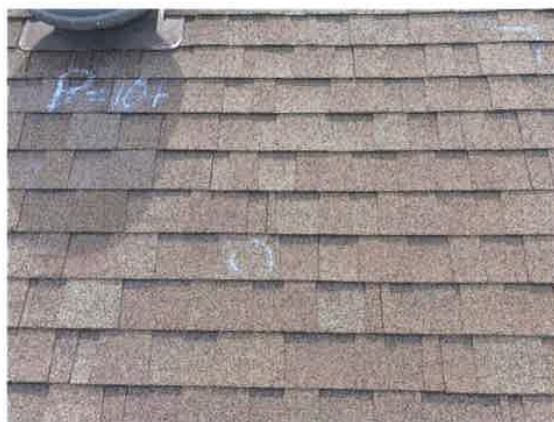
Back Slope - Roof Condition

Good Condition

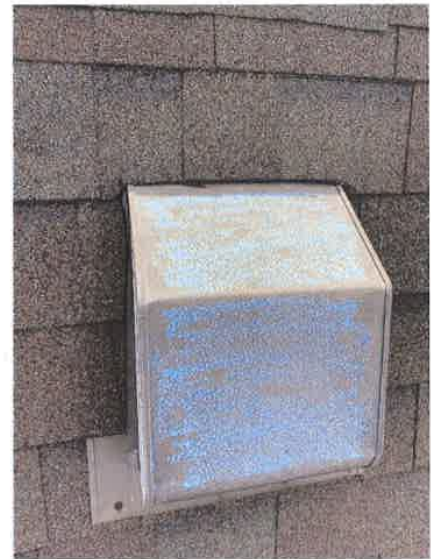
Accessory - Back Slope

Box Vent

Aluminum

Storm related damage caused by hail

Unsealed Condition

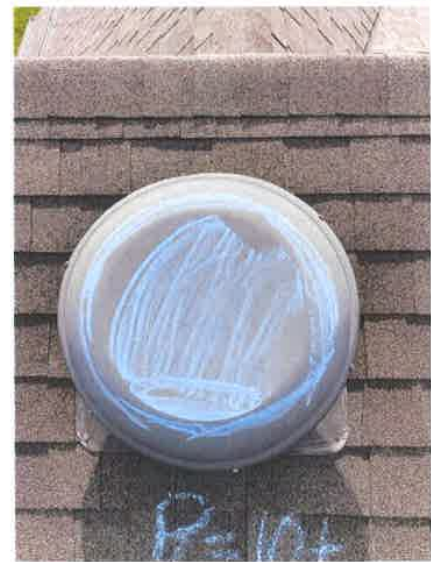
Accessory - Back Slope

Power Vent

Galvanized

No Damage

Size: Medium

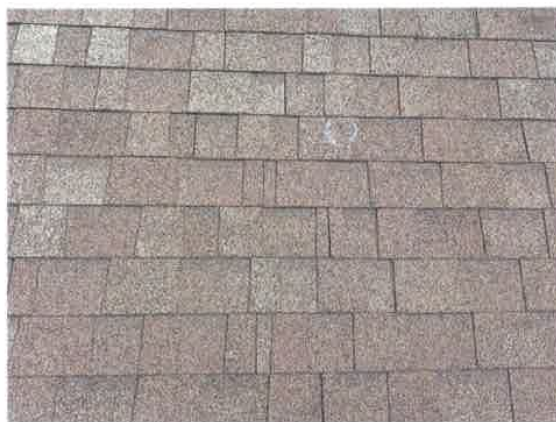
Left Slope - Roof Condition

Good Condition
